Ford SCME Ground Wire Repair and Modification

Author: Bill Rowe

Dated: 09-Feb-20

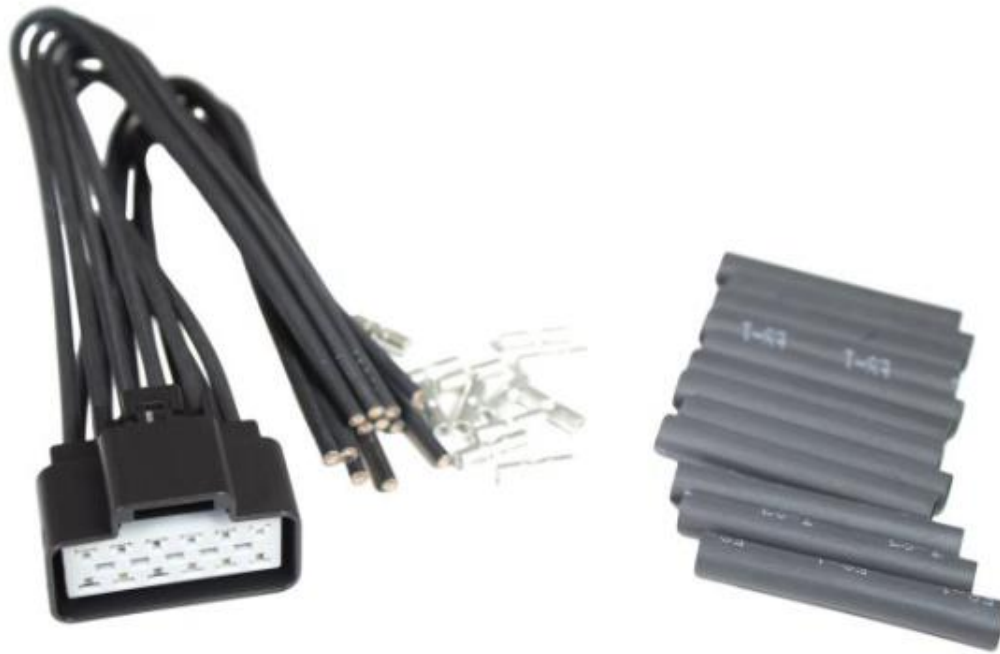
Figure 14 - Motorcraft WPT-928 Package Contents

The pigtail is available from a variety of suppliers under the Ford P/N 3U2Z-14S411-ZMB or Motorcraft P/N WPT-928. The package includes crimp connectors and heat shrink tubing to facilitate splicing in the new wires with pre-crimped terminals along with an instruction sheet. This is handy if you do not have a proper terminal crimper. Figure 14 shows the components of the package.
