Sync Connect APIM & TCU Files/Programming/Activating.

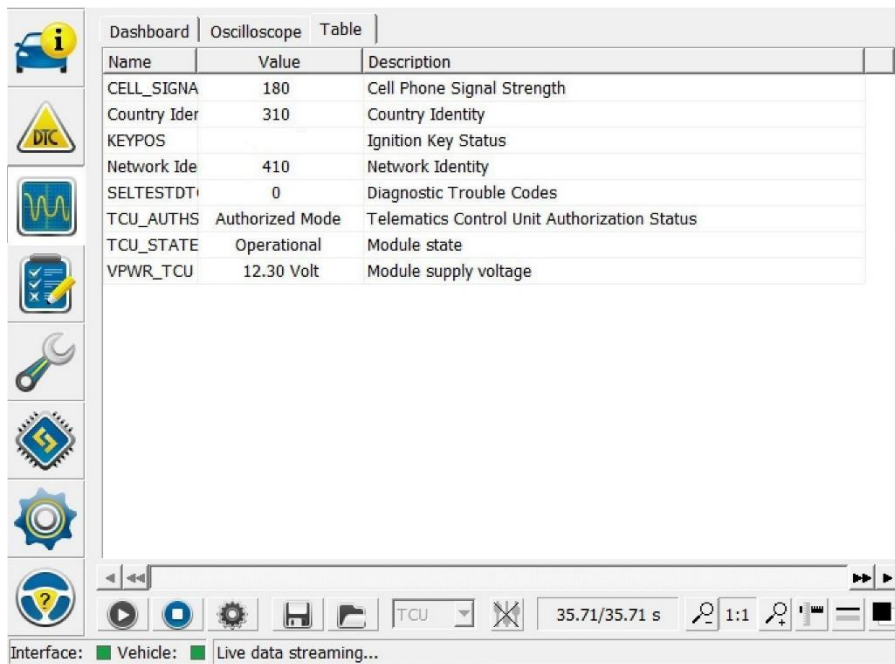
6. Once the message appears on the APIM to authorize, confirm you want to authorize. If the message takes more than about 5 minutes, turn off the vehicle and open and close the door to ensure that the APIM powers down. Restart the vehicle. Wait for the message... authorize the vehicle.
7. You should get an email or message in FordPass that the vehicle is now authorized. If you do not receive these emails then the process is failing on the FORD side, not the vehicle side. Sometimes the emails or message in FordPass will take several minutes. Once the vehicle authorizes, you will see the status in FORScan monitoring the TCU PID's.

Name	Value	Description
CELL_SIGNA	180	Cell Phone Signal Strength
Country Ider	310	Country Identity
KEYPOS		Ignition Key Status
Network Ide	410	Network Identity
SELTESTDT	0	Diagnostic Trouble Codes
TCU_AUTHS	Authorized Mode	Telematics Control Unit Authorization Status
TCU_STATE	Operational	Module state
VPWR_TCU	12.30 Volt	Module supply voltage
