Sync Connect APIM & TCU Programming and Activating.

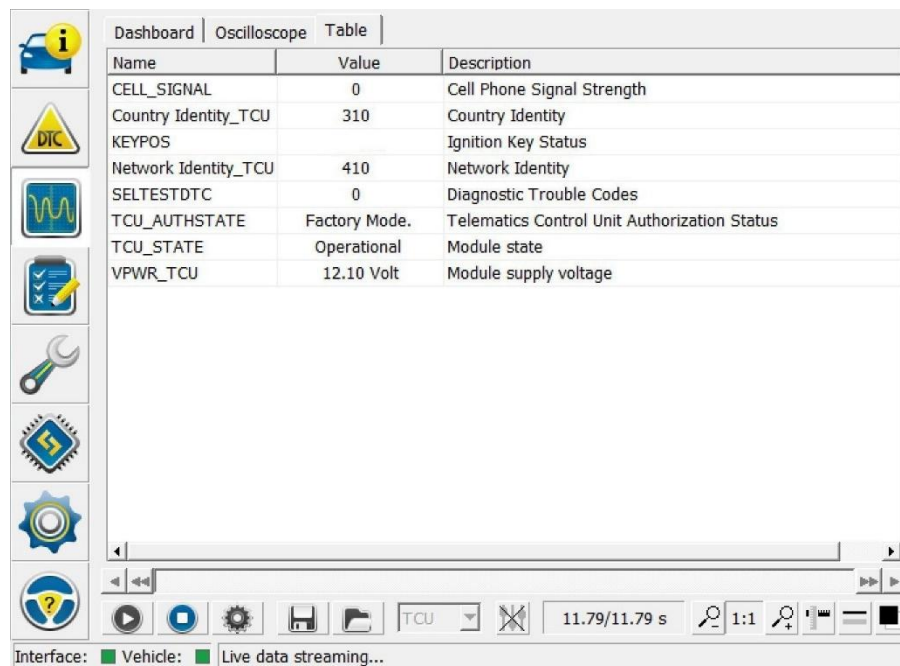
3. While monitoring the Authorization Status PID, it will progress through several stages as shown in the images below. (Factory Mode, Unprovisioned Mode, Waiting for Authorization Mode).

Name	Value	Description
CELL_SIGNAL	0	Cell Phone Signal Strength
Country_Identity_TCU	310	Country Identity
KEYPOS		Ignition Key Status
Network_Identity_TCU	410	Network Identity
SELTESTDTC	0	Diagnostic Trouble Codes
TCU_AUTHSTATE	Factory Mode.	Telematics Control Unit Authorization Status
TCU_STATE	Operational	Module state
VPWR_TCU	12.10 Volt	Module supply voltage

- Disregard the ignition status and FORScan version in the pictures below.
1. In FORScan set up the TCU monitoring as shown in the images below.
 2. While monitoring the TCU PIDs in real time, there's a PID labeled 'TCU Authstate' which tells you the current authorization status of the module. To begin the process of activating or authorizing the TCU, change the value of 754-01-01 in FORScan to the value below:
754-01-01: B133 0000 0041 (This is for NA region.)
...wait a few minutes. Check that the TCU Auth state says, 'Factory Mode', then set it back to the original value. This changes the OCS state to 'Not Configured'.
(754-01-01 B132 0000 0040 if using the asbuilt data above.)

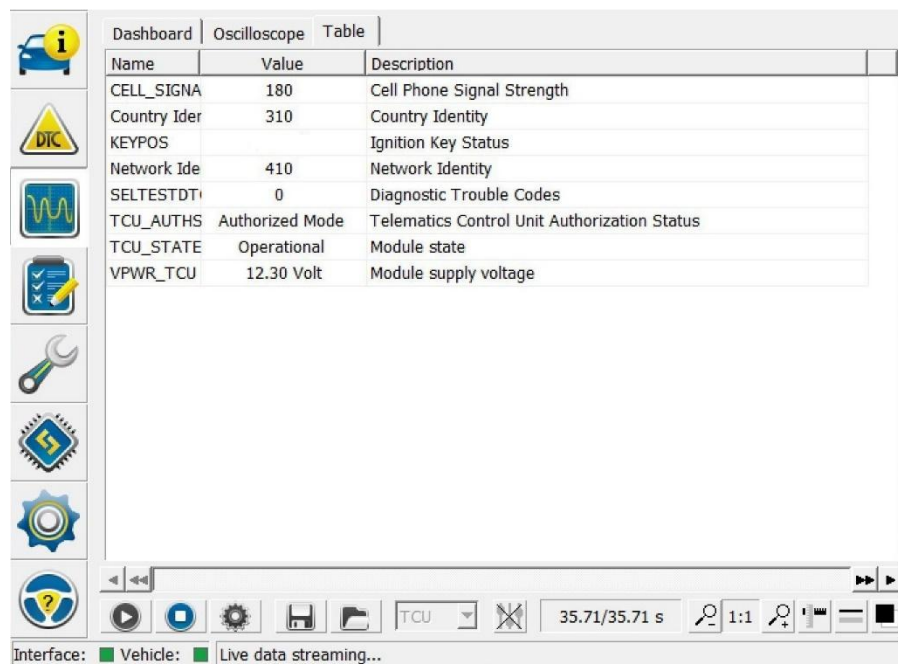
6. Once the message appears on the APIM to authorize, confirm you want to authorize. If the message takes more than about 5 minutes, turn off the vehicle and open and close the door to ensure that the APIM powers down. Restart the vehicle. Wait for the message... authorize the vehicle.
7. You should get an email or message in FordPass that the vehicle is now authorized. If you do not receive these emails then the process is failing on the FORD side, not the vehicle side. Sometimes the emails or message in FordPass will take several minutes. Once the vehicle authorizes, you will see the status in FORScan monitoring the TCU PID's.

Name	Value	Description
CELL_SIGNA	180	Cell Phone Signal Strength
Country Id	310	Country Identity
KEYPOS		Ignition Key Status
Network Ide	410	Network Identity
SELTESTDT	0	Diagnostic Trouble Codes
TCU_AUTHS	Authorized Mode	Telematics Control Unit Authorization Status
TCU_STATE	Operational	Module state
VPWR_TCU	12.30 Volt	Module supply voltage
