Sync Connect APIM & TCU Files/Programming/Activating.

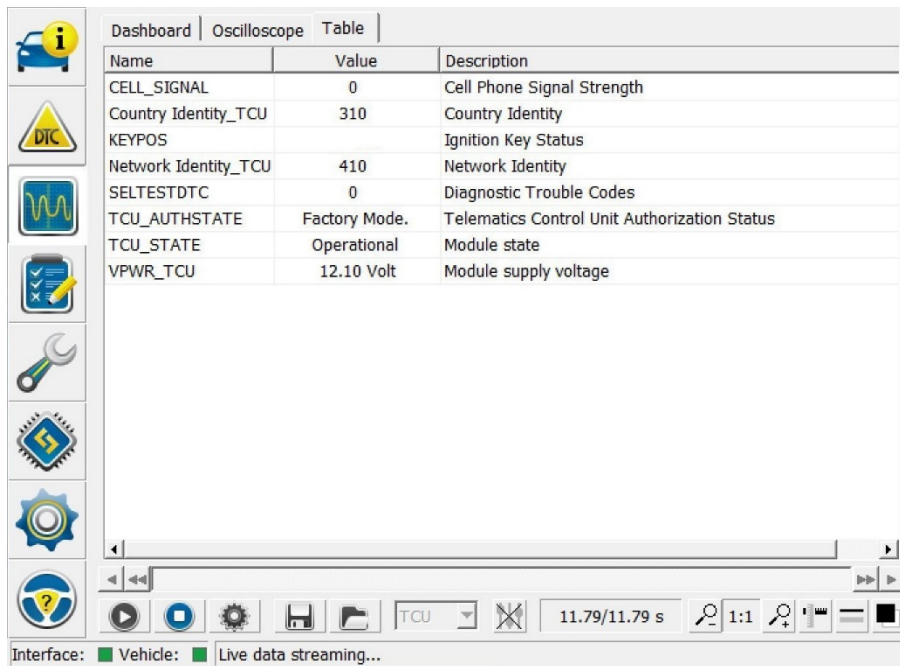
3. While monitoring the Authorization Status PID, it will progress through several stages as shown in the images below. (Factory Mode, Unprovisioned Mode, Waiting for Authorization Mode).

Name	Value	Description
CELL_SIGNAL	0	Cell Phone Signal Strength
Country_Identity_TCU	310	Country Identity
KEYPOS		Ignition Key Status
Network_Identity_TCU	410	Network Identity
SELTESTDTC	0	Diagnostic Trouble Codes
TCU_AUTHSTATE	Factory Mode.	Telematics Control Unit Authorization Status
TCU_STATE	Operational	Module state
VPWR_TCU	12.10 Volt	Module supply voltage

- Disregard the ignition status and FORScan version in the pictures below.
1. In FORScan set up the TCU monitoring as shown in the images below.
  2. While monitoring the TCU PIDs in real time, there's a PID labeled 'TCU Authstate' which tells you the current authorization status of the module. To begin the process of activating or authorizing the TCU, change the value of 754-01-01 in FORScan to the value below:  
754-01-01: B133 0000 0041 (This is for NA region.)  
...wait a few minutes. Check that the TCU Auth state says, 'Factory Mode', then set it back to the original value. This changes the OCS state to 'Not Configured'.  
(754-01-01 B132 0000 0040 if using the asbuilt data above.)
